S J Johnson Associates Ltd
Chartered Structural Engineers

**STRUCTURAL APPRAISAL / REPORT
IN CONNECTION WITH REPORTED
POSSIBLE SUBSIDENCE DEFECTS**

GLoucester

20-05-

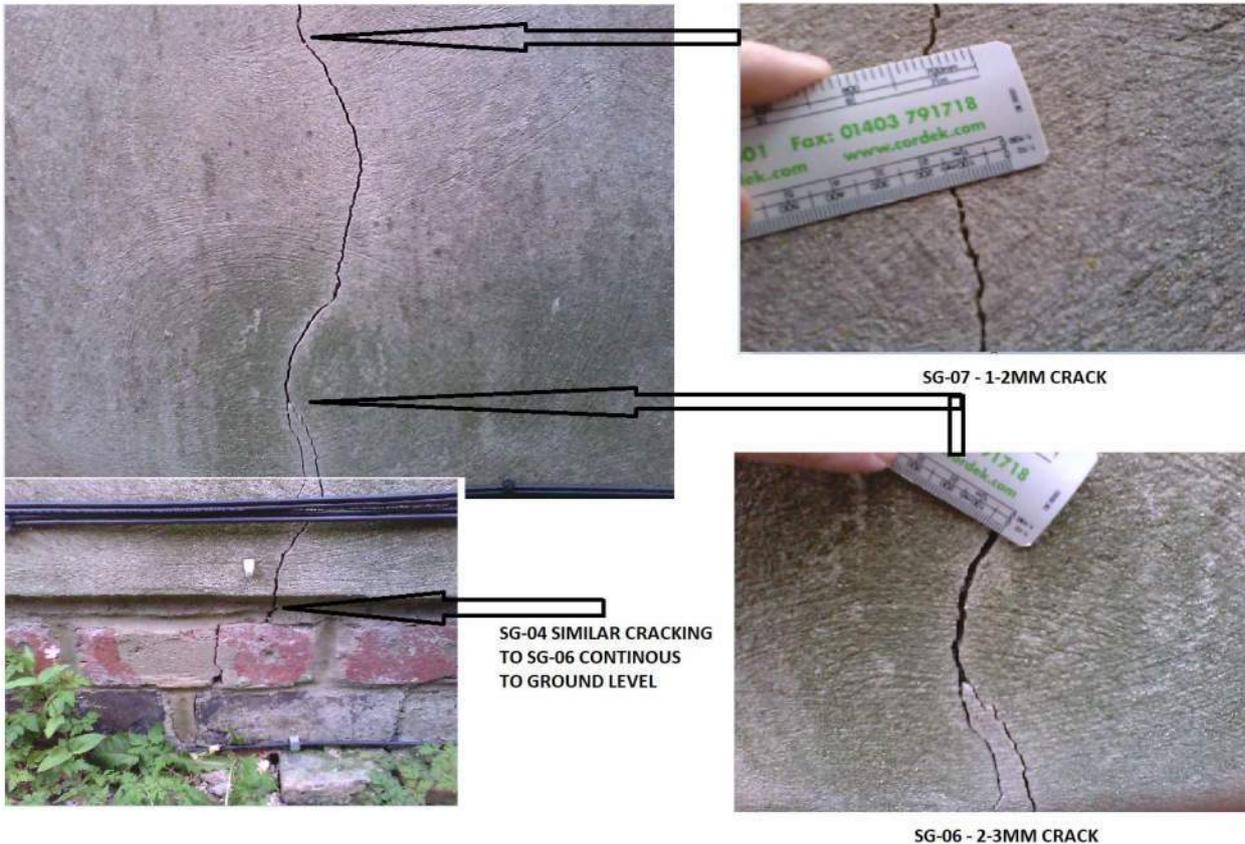
Ref Photos SG-04-07, collated below over the wider view of **SG03** for clarity, it can be seen that a crack has manifested, appearing from external ground level currently (**SLIGHT**) at 3mm, narrowing to 1-2mm as it progresses up the gable wall.

It is my view at this time, that this cracking is the result of settlement due to dessication subsidence caused by the foliage at the boundary, most likely with primacy attributable to the plumb cherry detailed later.

Without the controlled removal or pollarding of trees, It would appear necessary to underpin the south gable as an absolute minimum this based on current observable defects. Further uncontrolled growth of the trees discussed are likely to put the RH-front bay and rear kitchen annex at risk of future subsidence.

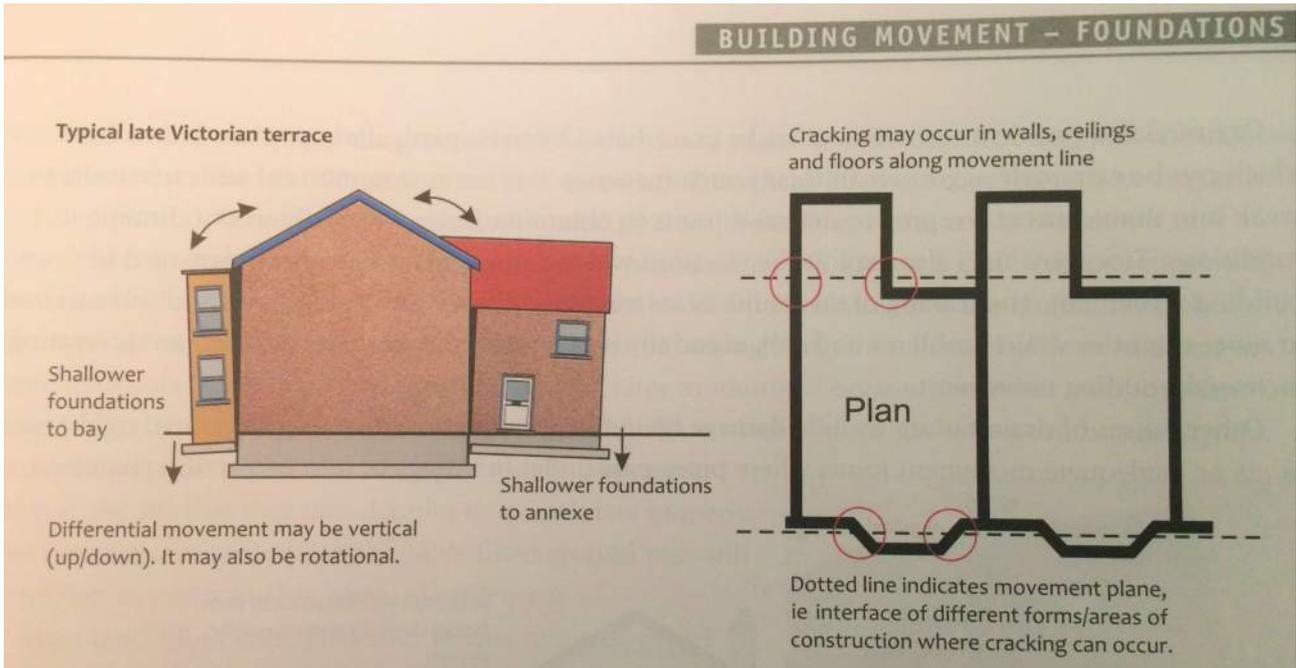
Ref photos TP-01-07, a trial pit was dug to formation which exposed the RH-bays footing depth as expected for this age of property at approximately 6.5 inches below external ground level. Such shallow footings are known to cause lean as discussed above and pictured below **Ref[2]**, findings remain as above.

Lean often caused by shallow bay footings – Ref [2] Understanding Building Defects by Marshall / Worthing / Heath.

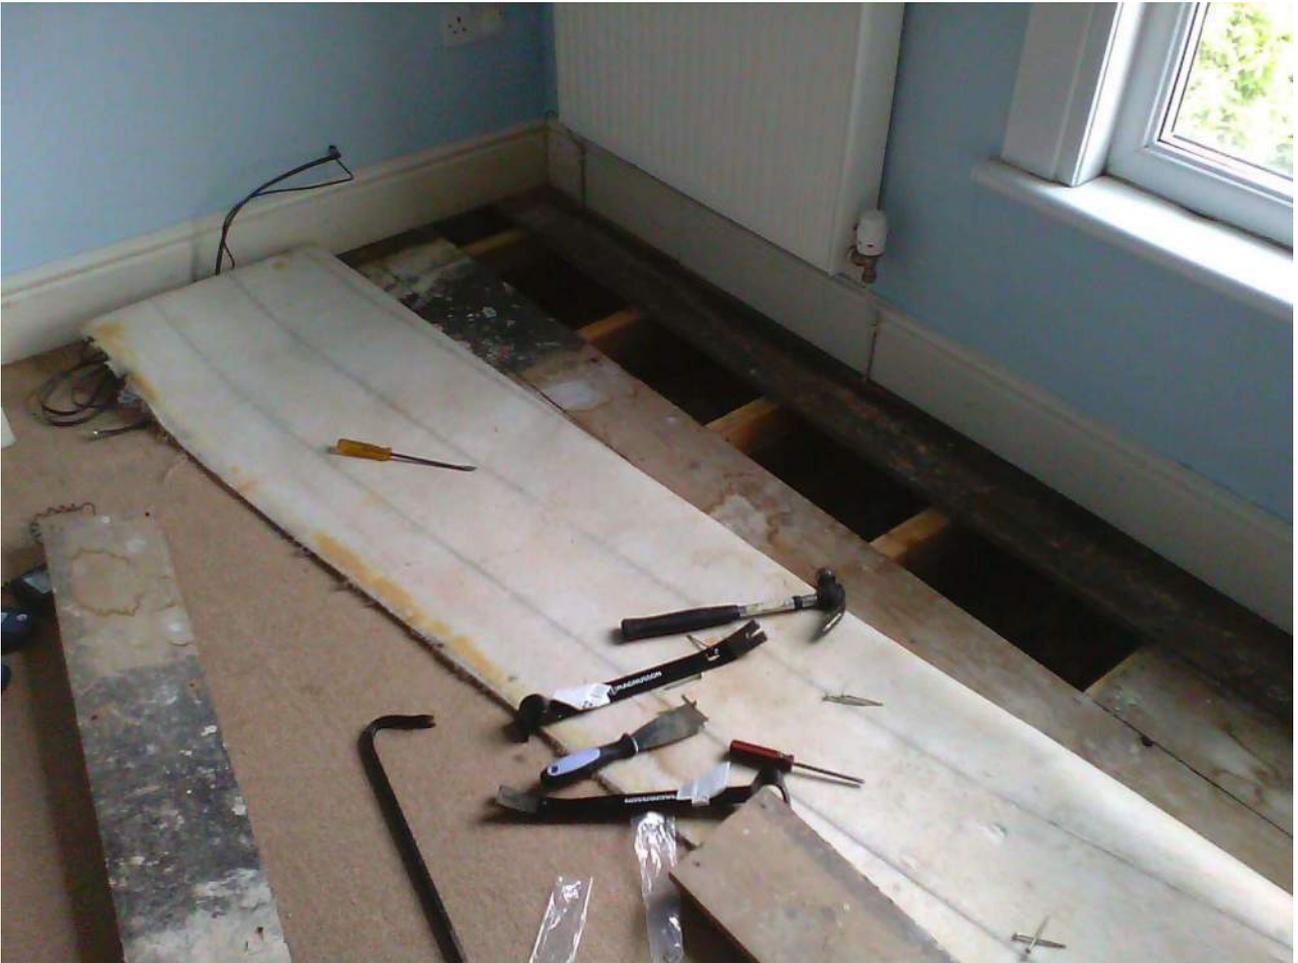
Ref Photo **RH-BRM-01**, Loss of 1st floor diaphragm was investigated with six joists exposed as pictured. All appeared robust as they entered the wall, with no signs of rot observable.

RH-BRM-01 - JOIST ENDS EXPOSED ALL SIX INSPECTED SHOWING NO SIGNS OF DETERIORATION AT THE ENDS AS THEY ENTERED THE FRONT WALL, DIAPHRAGM APPEARS SATISFACTORILY FOR BUILDING CONSTRUCTION ERA.

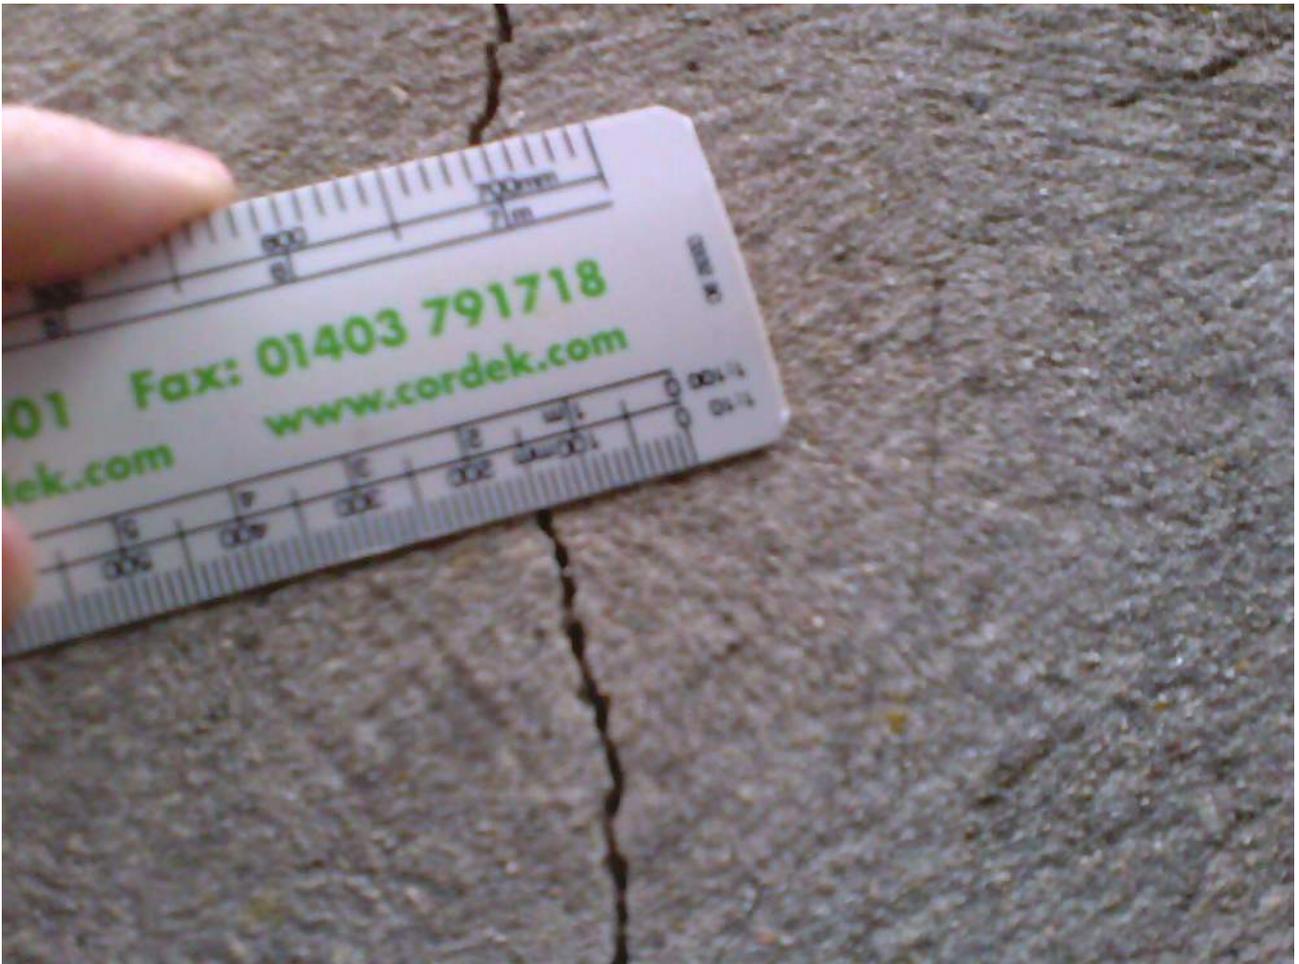
SG-07 CRACK SHOWN IN PHOTO SG-03 CIRCA 1-2mm HIGHER LEVEL

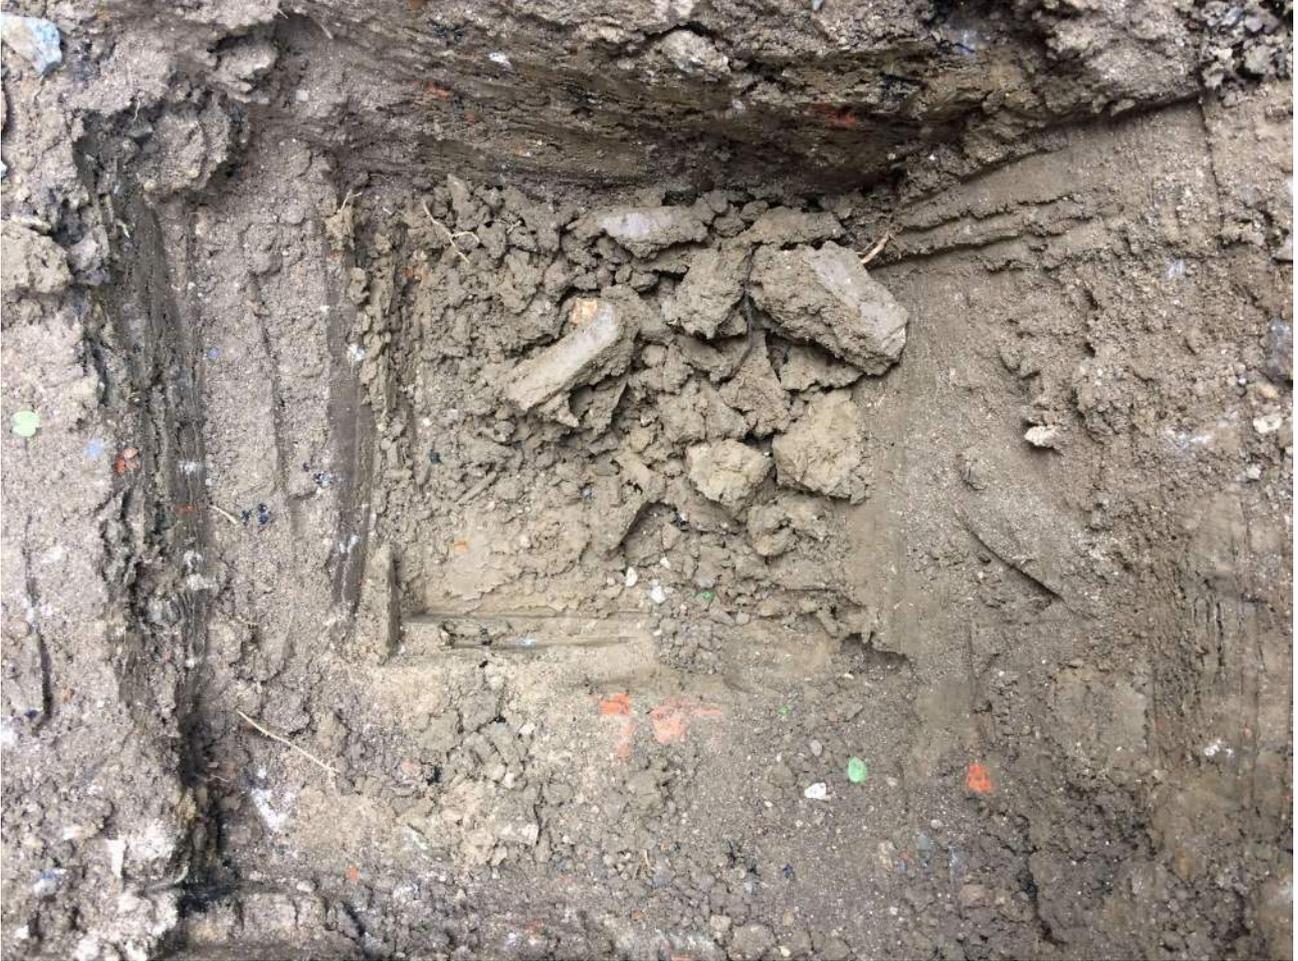
Arisings from the excavation showed at first sandy clay (**Ref TP-02**), becoming more consistent lumpy clay at approximately 300mm depth (**Ref TP-03 & 06**). This was as expected, with British Geological Survey Mapping **Ref[3]** showing superficial deposits of clay, silts, sands and gravels as repeated below, with the bedrock map (not shown) relating Lias and Mudstone at depth.

TP-03 MORE LUMPIER CONSISTANT CLAY AT APPROX 300mm

With this in mind, it poses the question if the clay content might affect the ability to utilise an injection under pinning system? It is recommended that if this route is to be considered that appropriate testing and review of soil type is undertaken, and confirmed as acceptable by the supplier.

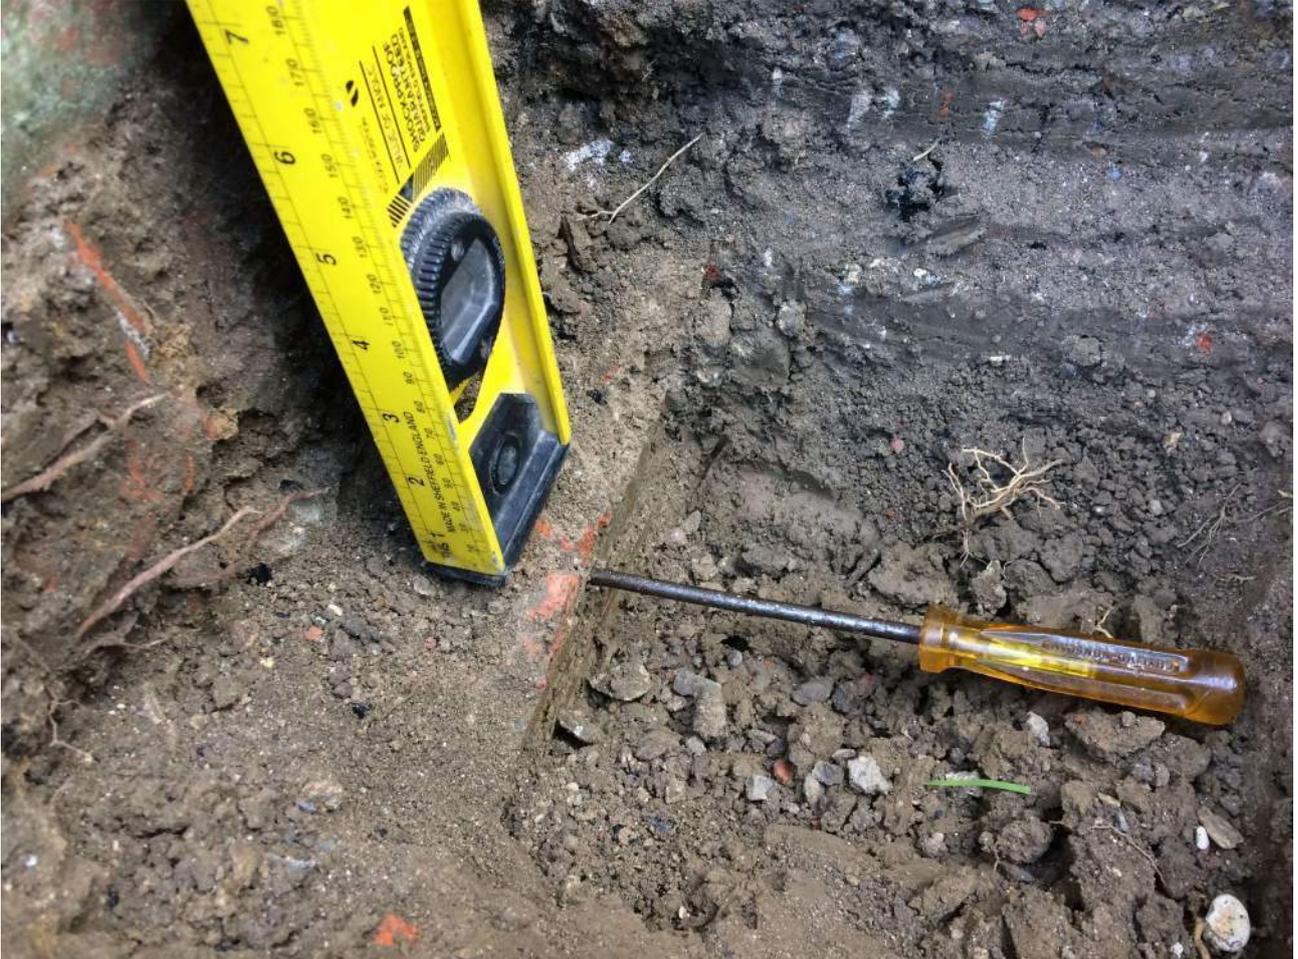
TP-4 FOOTING FLARES OUT AT APPROX 7 INCHES - SCREW DRIVER INSERTED BELOW DEFINING FORMATION AT 8 INCHES

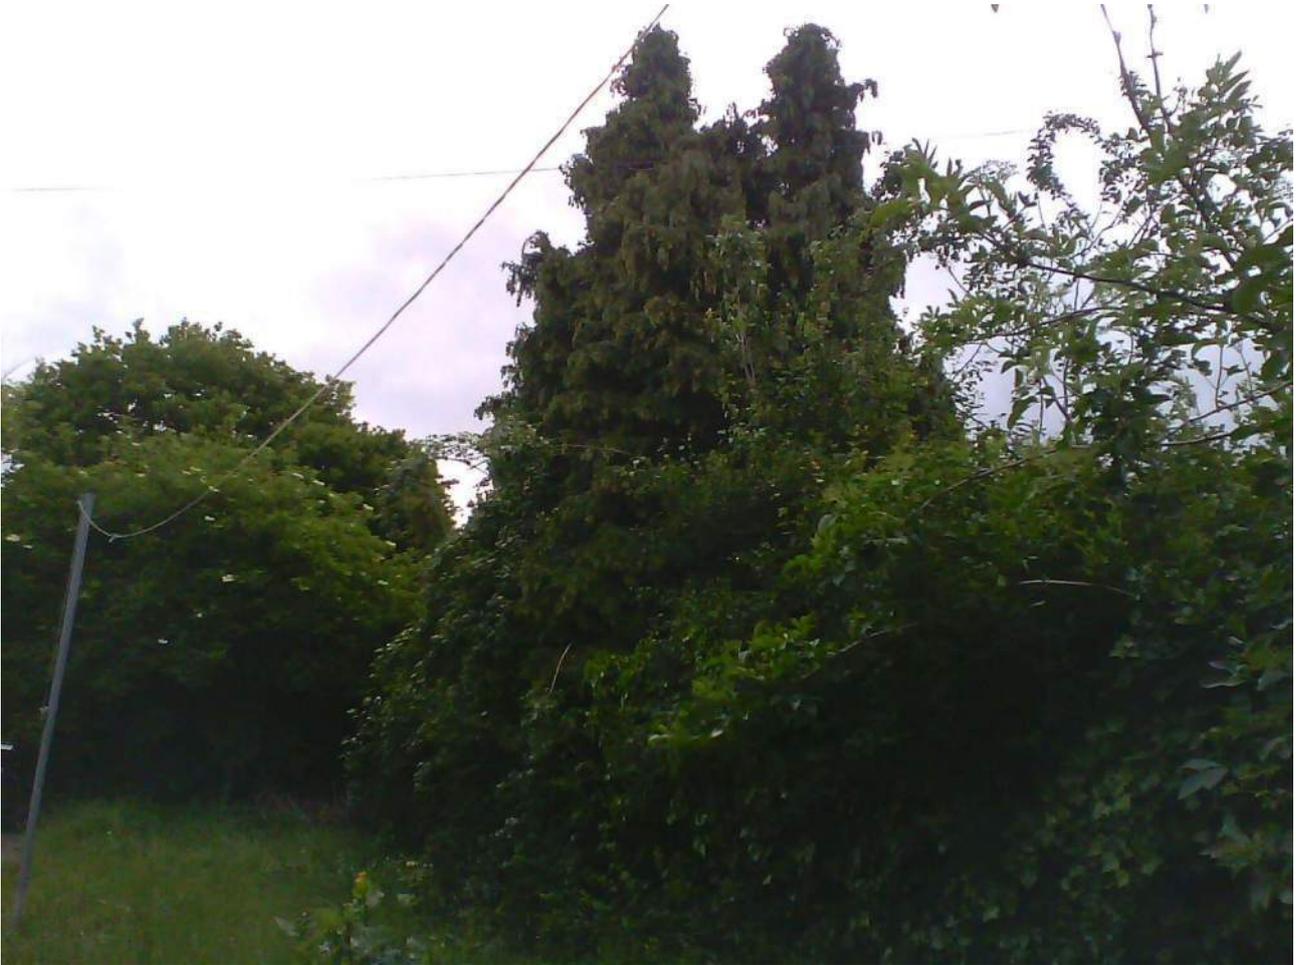
Ref photos T1-3, at least 3no 8m tall - Lawson Cypress are present the first being at a 9m offset from the kitchen. Assuming high plasticity clays (until tests prove otherwise), these trees at their current height require a footing depth of 1.37m (**photo T3**) to avoid affect. It is likely with reference to Marshall / Worthing / Heath above, NHBC **Figure 6** [4] below and the elevation of these trees, that the kitchen annex is on the point of experiencing subsidence from these trees alone, not diminishing the effects of other planting on the neighbours side of the boundary.

TI - LAWSON CYPRESS TO REAR CURRENTLY 8M TALL NEAREST AT 9M OFFSET AT +1.5M ELEVATION INCREASE

Concerning the rear annex, controlled removal or pollarding of the Lawson Cypress is advised to avoid potentially immanent subsidence to this area.

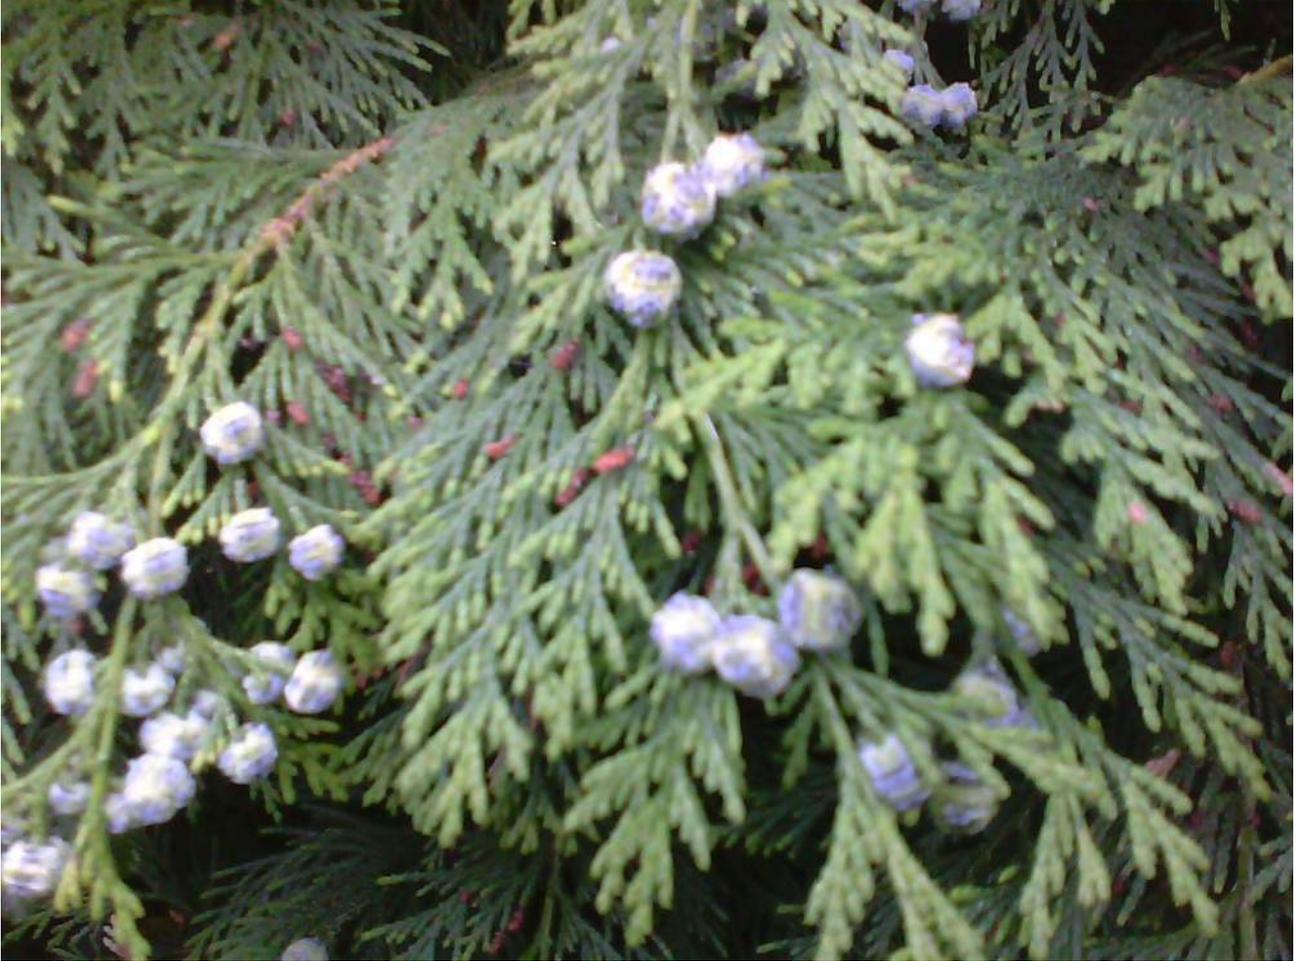
T2 - LAWSON CYPRESS - FRUITS FOR TREE ID

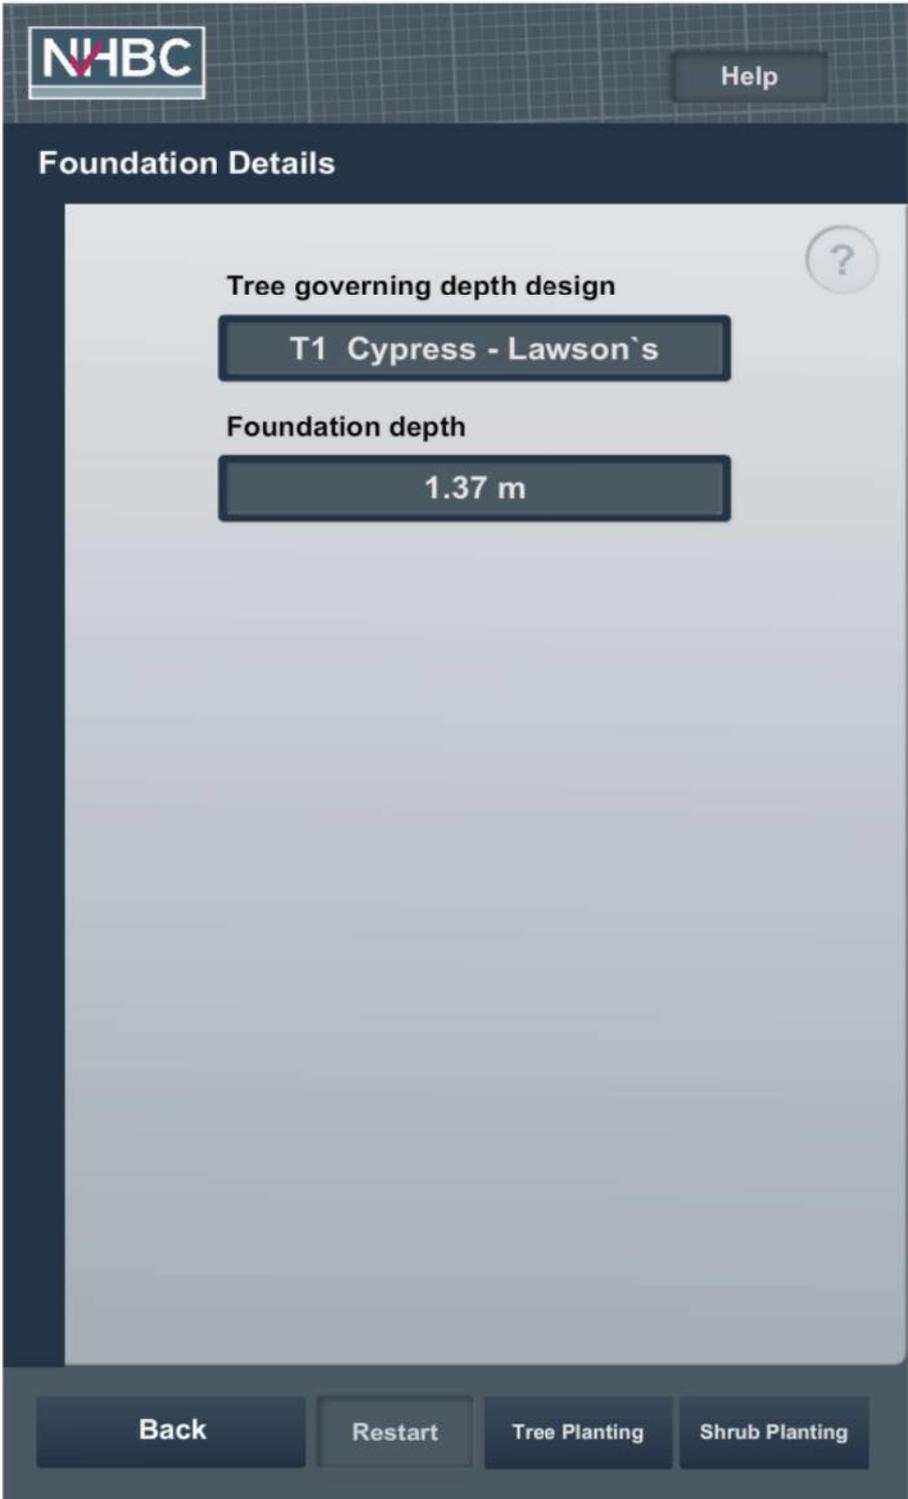
T3 – REQUIRED FOOTING DEPTH BY NHBC FOUNDATION DEPTH CALCULATOR APP – ASSUMING high PLASTICITY - IGNORING ELEVATION INCREASE***

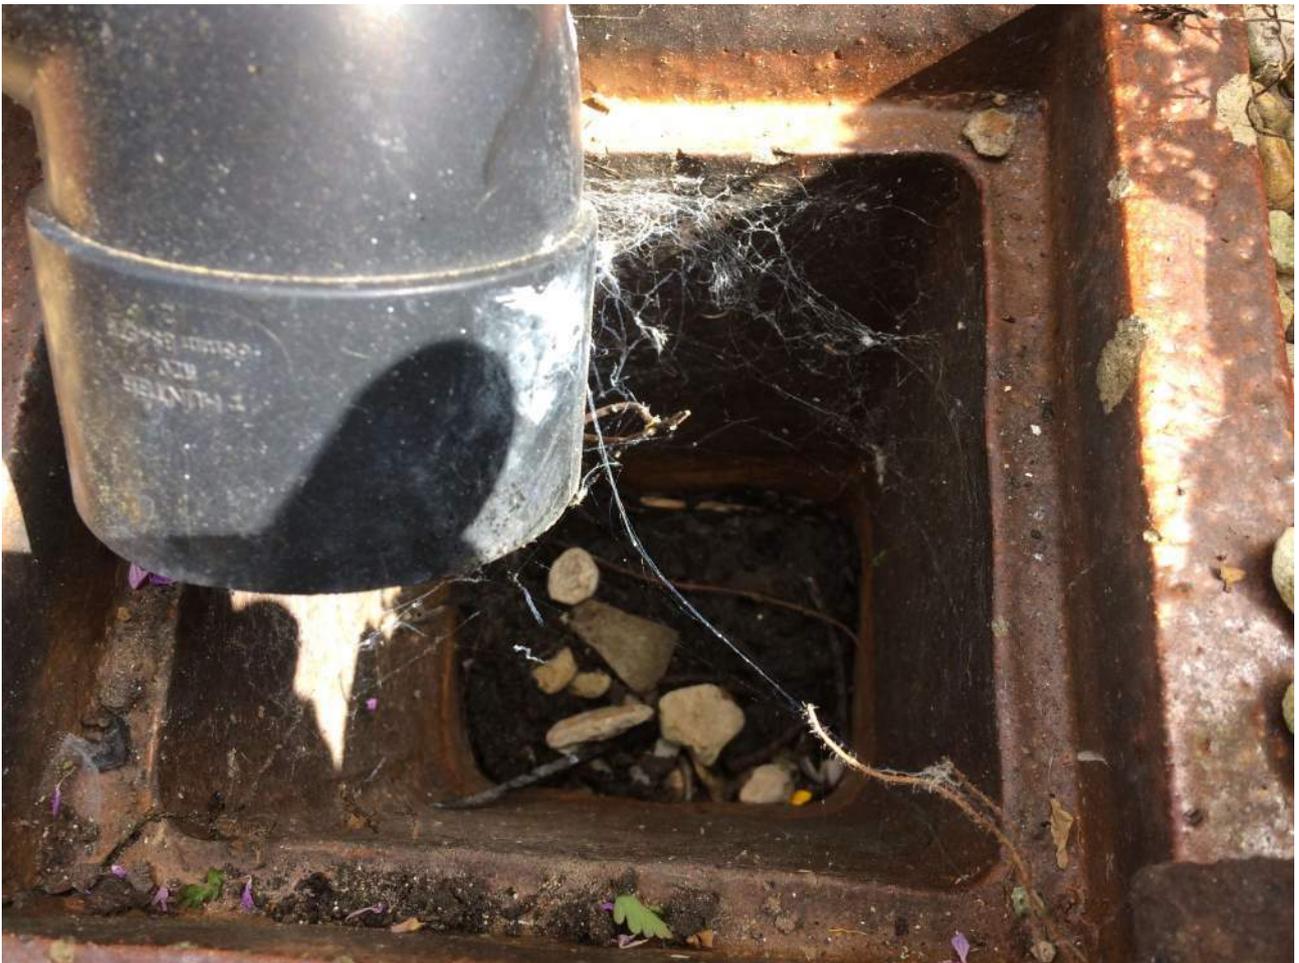
It is apparent from Photo **DR-5** that the drain on the South Gable appears blocked and I would recommend that this is addressed. However with nearby cracks narrowing as they progress up this wall, as described and shown in section 4. It seems that the current issue is one of tree dessication and settlement rather than excess water and heave associated with leaking drains.

DR-5 - DRAIN ON SOUTHERN GABLE IMEDIATLEY ADJACENT TO PLUMB CHERRY, SHOWN TO BE BLOCKED UPON REMOVAL OF GRATE ETC

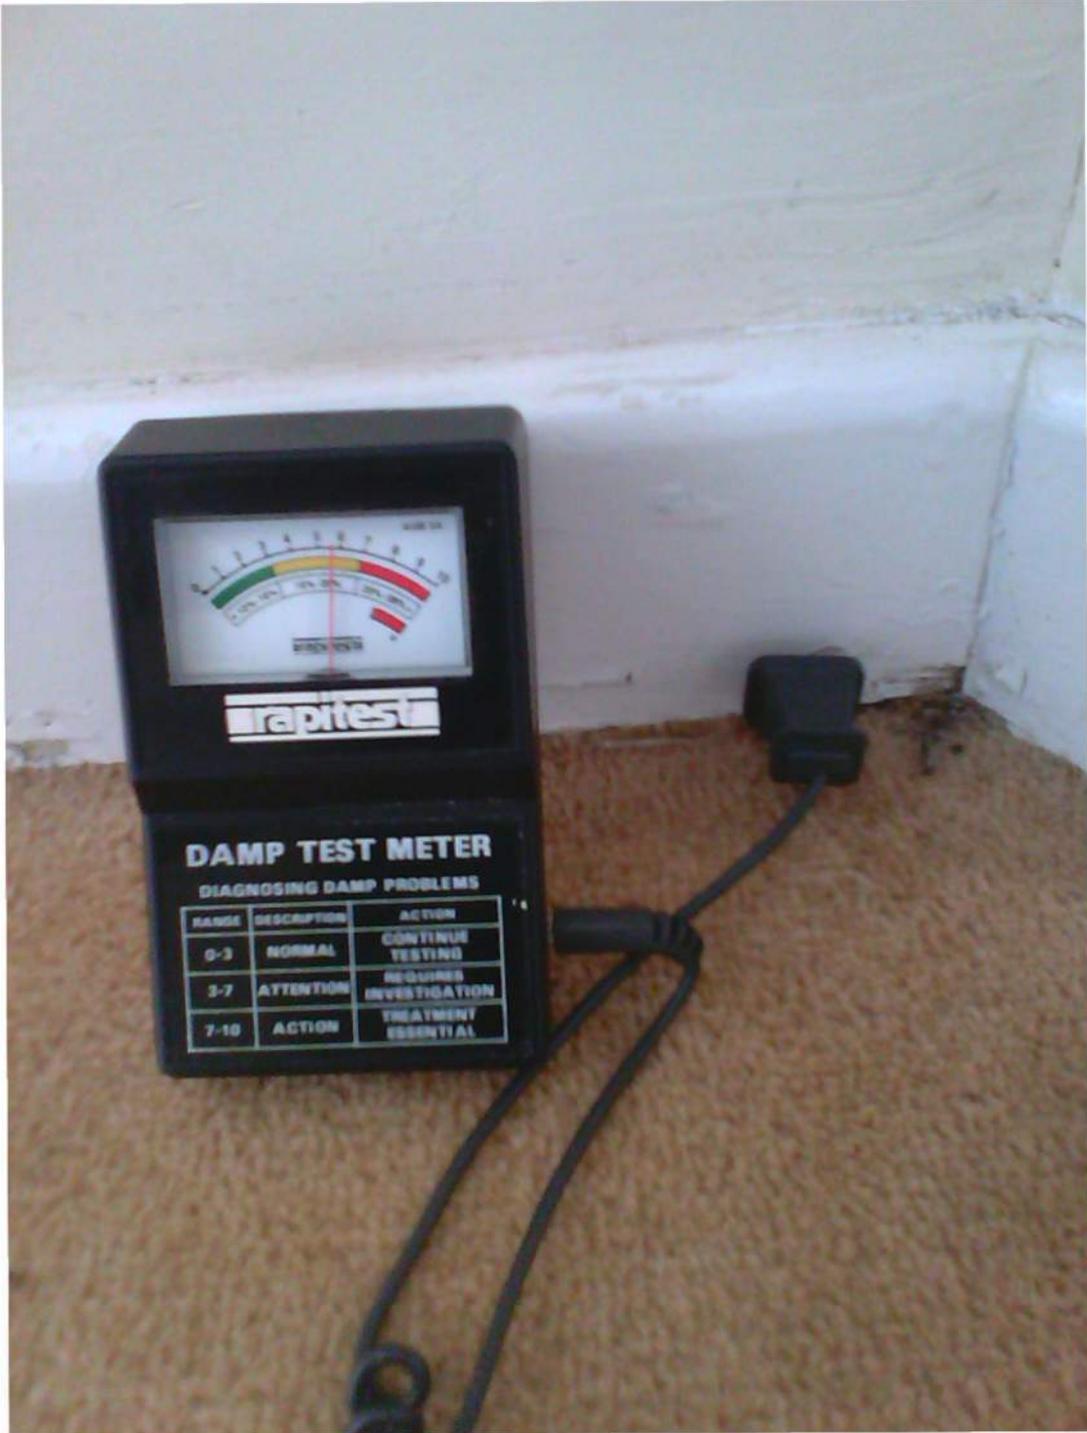
D2 - LH BAY - INTERNAL RH CORNER
