S J Johnson Associates Ltd
Chartered Structural Engineers

**STRUCTURAL APPRAISAL / REPORT
IN CONNECTION WITH REPORTED
POSSIBLE SUBSIDENCE DEFECTS**

GLoucester

20-05-

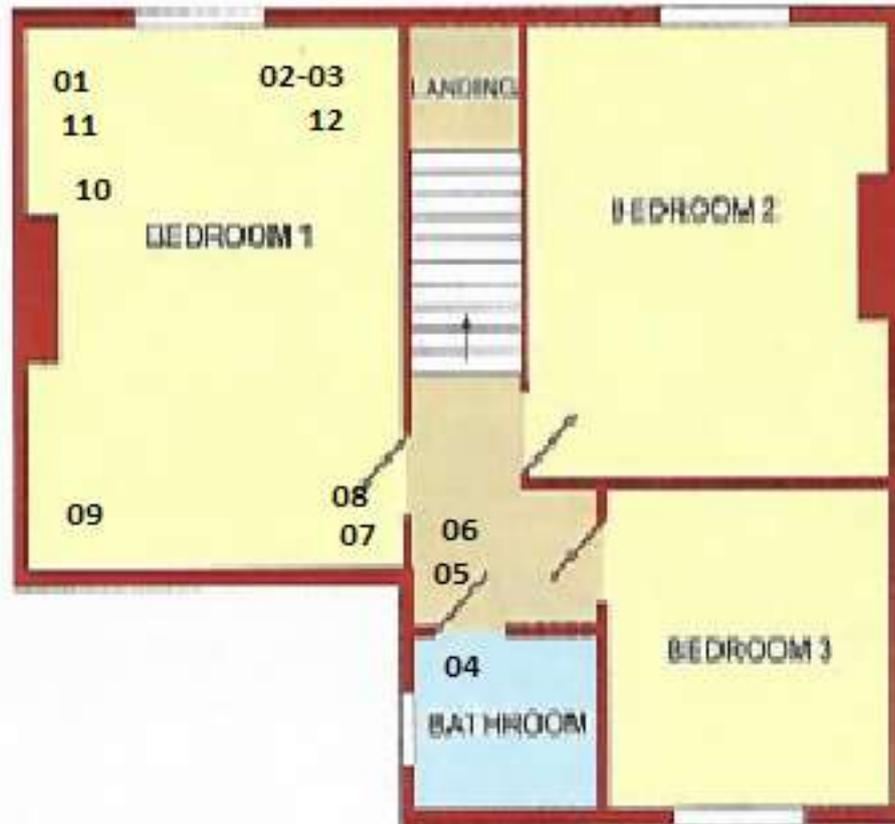
RIGHT HAND BEDROOM
PICTURE PLAN ALL
PHOTOS HAVE PREFIX
RHBR IN REPORT

Ref Photo **RH-BRM-01**, Loss of 1st floor diaphragm was investigated with six joists exposed as pictured. All appeared robust as they entered the wall, with no signs of rot observable.

Ref Photo's RH-BRM-02-03 a crack has manifested under the RH side of the window looking outwards. The crack propagates from skirting board level to a current maximum aperture of some 4mm – classification therefore currently (**SLIGHT**). **Ref Photo FW-38**, the action of the internal cracking being reflected in part in the more ductile lime mortared outside face. Current symptoms being, a rotation of the Sill and a possibly related tear in the flashing.

Ref Photos RH-BRM-04-11, a significant length of cracking has manifested in recent times. Commencing in the adjacent WC **Photo(04)**, then tracking through the landing **photos(05-06)**, re-emerging in the RH Bedroom and tracking up currently from the light switch area to ceiling level. Cracking widens to 6mm here, and to a similar (**MODERATE**) severity in the landing area. After reaching the bedroom ceiling ref **photos (07-11)** the crack appears to continue as a shear crack synonymous of the ceiling sliding relative to the walls, this cracking continuing in a clockwise manner around the ceiling, around the gables chimney breast and terminating in the front wall above the cracking at the window discussed above, **Ref Photo's RH-BRM-02-03**.

Based on the observations above, it is my view that the movement and cracking discussed here at this time is attributable to subsidence settlement at the southern gable, which will be discussed next.

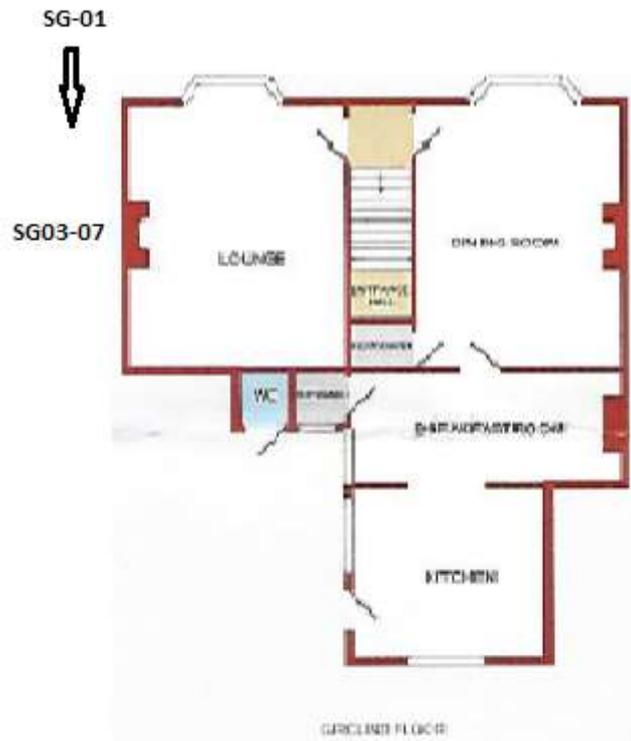
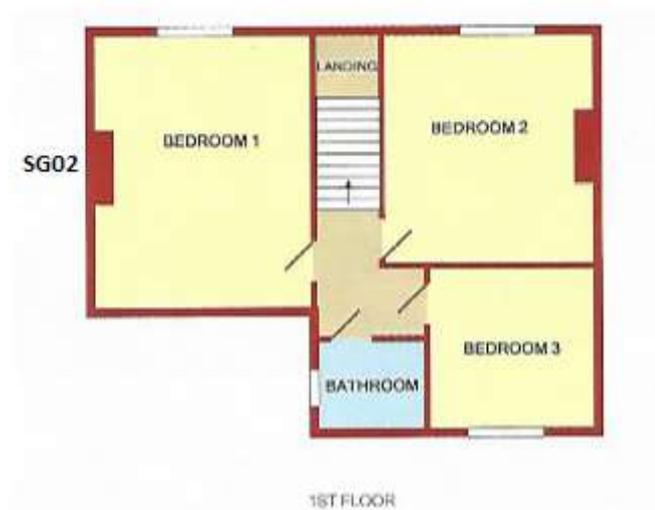
Ref Photos SG-04-07, collated below over the wider view of **SG03** for clarity, it can be seen that a crack has manifested, appearing from external ground level currently (**SLIGHT**) at 3mm, narrowing to 1-2mm as it progresses up the gable wall.

It is my view at this time, that this cracking is the result of settlement due to dessication subsidence caused by the foliage at the boundary, most likely with primacy attributable to the plumb cherry detailed later.

Other notable defects are a loss of mortar at the ridge/verge, which may also be attributable to this settlement – as shown in **photo SG-02**.

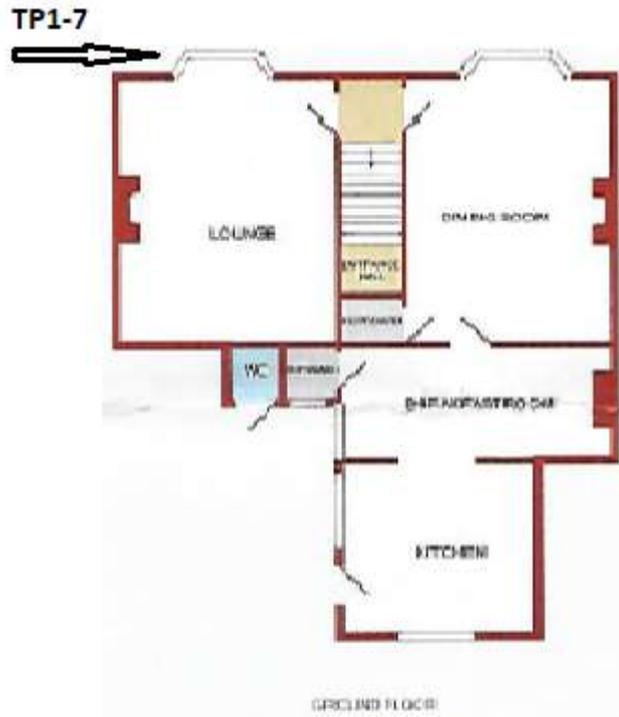
**TRIAL PIT PHOTOS
PLAN TP1-7**

Ref photos TP-01-07, a trial pit was dug to formation which exposed the RH-bays footing depth as expected for this age of property at approximately 6.5 inches below external ground level. Such shallow footings are known to cause lean as discussed above and pictured below **Ref[2]**, findings remain as above.

With this in mind, it poses the question if the clay content might affect the ability to utilise an injection under pinning system? It is recommended that if this route is to be considered that appropriate testing and review of soil type is undertaken, and confirmed as acceptable by the supplier.

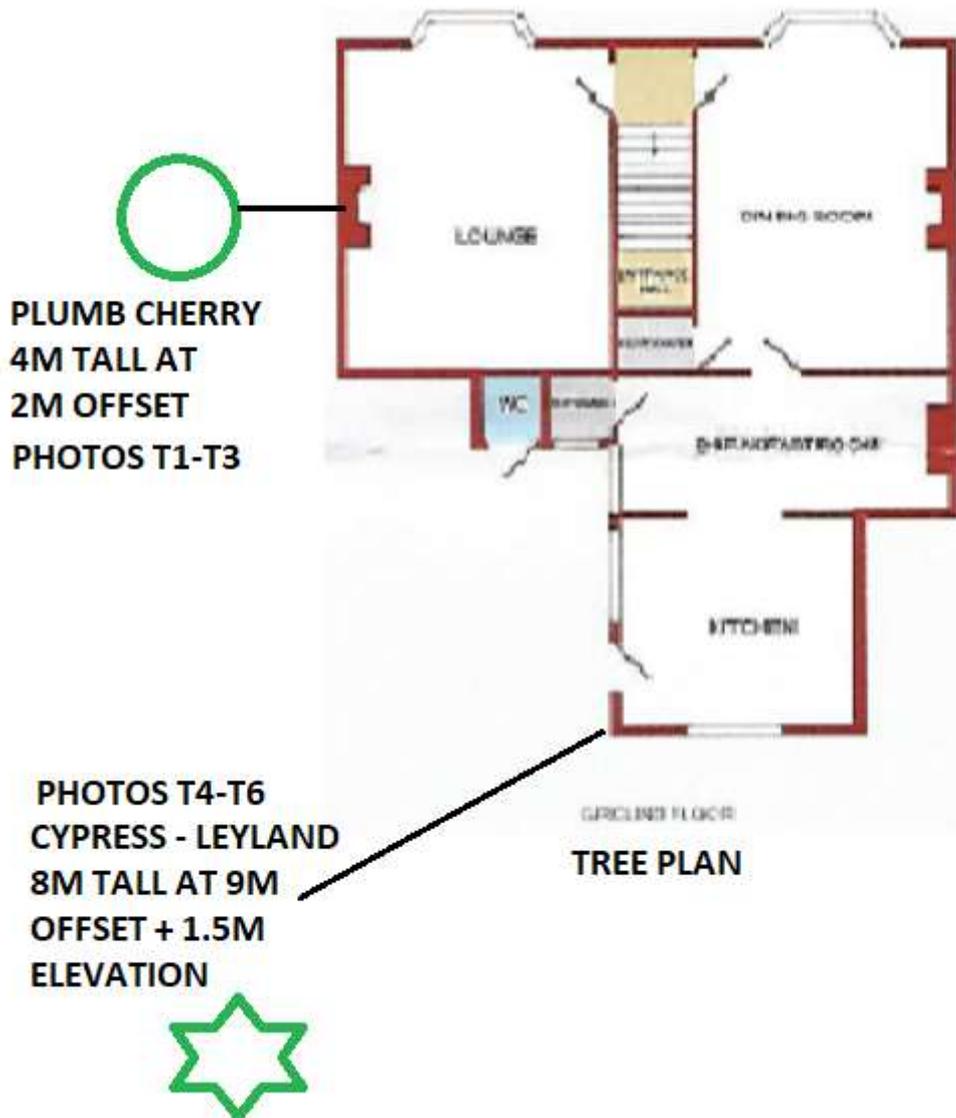
Ref photos T1-3, at least 3no 8m tall - Lawson Cypress are present the first being at a 9m offset from the kitchen. Assuming high plasticity clays (until tests prove otherwise), these trees at their current height require a footing depth of 1.37m (**photo T3**) to avoid affect. It is likely with reference to Marshall / Worthing / Heath above, NHBC **Figure 6** [4] below and the elevation of these trees, that the kitchen annex is on the point of experiencing subsidence from these trees alone, not diminishing the effects of other planting on the neighbours side of the boundary.

Ref photos T4-6, at least 1no 4m tall – Plumb Cherry has been identified 2m away from the South Gable cracking discussed above in section 4 **Ref Photos SG-04-06**. Assuming high plasticity clays (until tests prove otherwise), this tree(s) at current height require a footing depth of 2.04m to avoid affect. Similar Orchard Cherry used in the NHBC App (**Ref photo T6**), as Plumb Cherry not in NHBC App Register.

It is likely, due to the current slight nature of cracking currently observed that clay plasticity might not be high. Therefore to limit the amount of underpinning, it is recommended to have a laboratory test this.

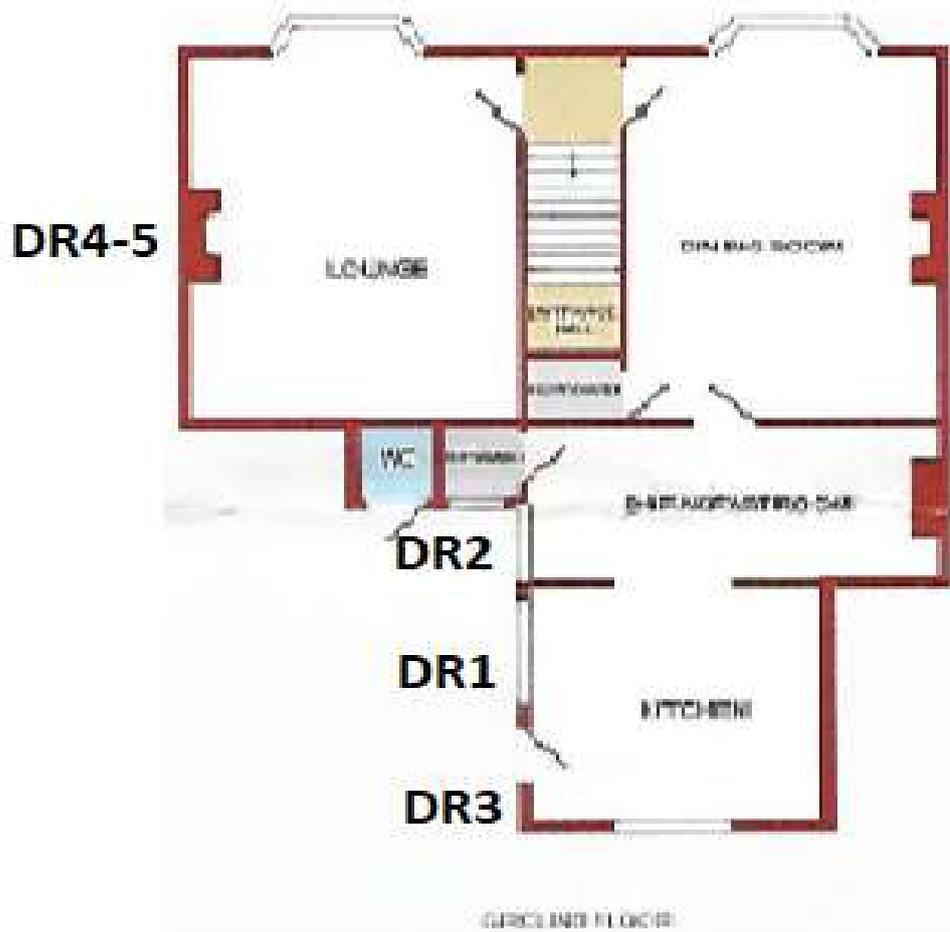
DRAINAGE PHOTOS DR1-5

It is apparent from Photo **DR-5** that the drain on the South Gable appears blocked and I would recommend that this is addressed. However with nearby cracks narrowing as they progress up this wall, as described and shown in section 4. It seems that the current issue is one of tree dessication and settlement rather than excess water and heave associated with leaking drains.

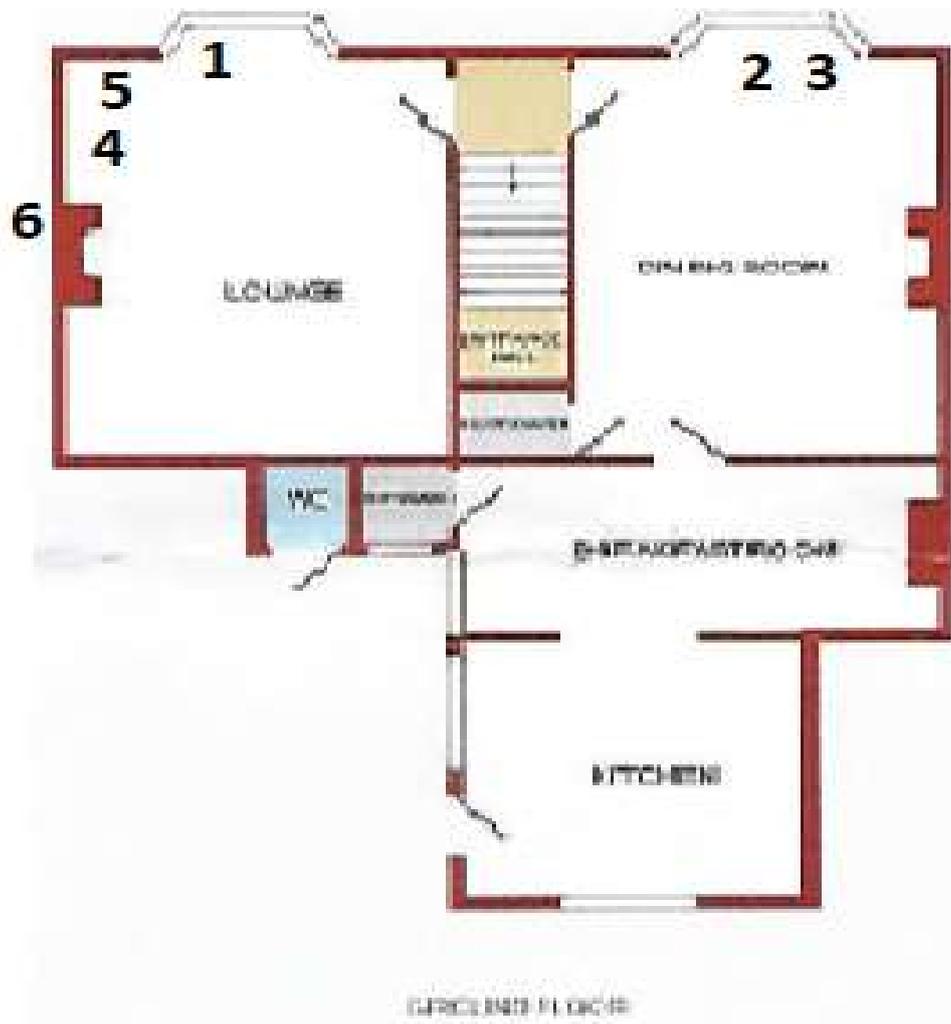
DAMP METER READS PHOTO D1 TO D6

As can be seen in section 8 of the photographic record, many readings for damp were taken in and around the property. Generally these showed good results - “GREEN – NORMAL -LVL 0-3 NO ACTION”, indicating at the locations tested that the injection damp proofing appears to still be functioning well. It was notable however in the LH Front room where the replacement concrete ground floor slab has been previously added, that damp readings were not so good. **Ref photos D2-3** upon initial insertion of the probe - “RED – ACTION LVL 7-10” readings were recorded. However this quickly fell off to -”ORANGE-ATTENTION LVL 3-7” by the time the camera was ready – possibly indicating damp caused by inadequate air circulation rather than other sources.
